NOTES BY MR. J. D. McCROY WHO SKETCHED THE DIFFERENT EVOLUTIONS OF THE BUCHANAN LOG HOUSE.

THE BUCHANAN LOG HOUSE, 18'x30' BUILDING, OUTLINE IDENTICAL TO WM PENN'S PLAN FOR IMMIGRANT HOUSES CA 1670, BUT WAS A "HALL AND PARLOR" (2 ROOMS) INSTEAD OF PENN'S THREE ROOMS ON FIRST FLOOR. (REFERENCE: ARCHITECTURE IN TENNESSEE 1768-1897; BY JAMES PATRICK, UNIVERSITY OF TENNESSEE PRESS 1990.

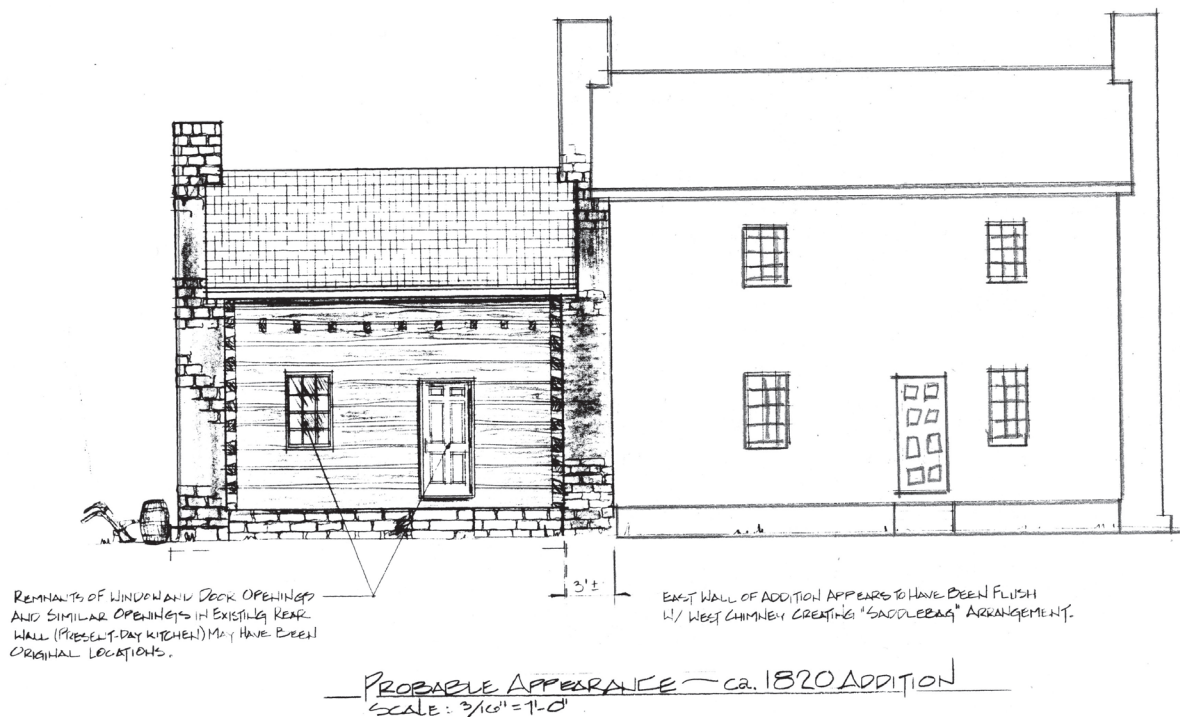
BELOW: PROBABLE APPEARANCE – CA 1820 ADDITION. EAST WALL OF ADDITION APPEARS TO HAVE BEEN FLUSH WITH WEST CHIMNEY, CREATING “SADDLEBAG” ARRANGEMENT. REMNANTS OF WINDOW AND DOOR OPENINGS AND SIMILAR OPENINGS IN EXISTING REAR WALL (PRESENT DAY KITCHEN) MAY HAVE BEEN ORIGINAL LOCATIONS.

POSSIBLE WEST ELEVATION – CA 1920. THE FIRST FLOOR WINDOWS CLOSED DURING LAST REMODELING TO CREATE INTERIOR NICHES. WINDOWS BASED ON FIELD OBSERVATIONS. ACCURATE HISTORICAL “AS-BUILT” DATA NOT AVAILABLE AT DRAWING DATE.

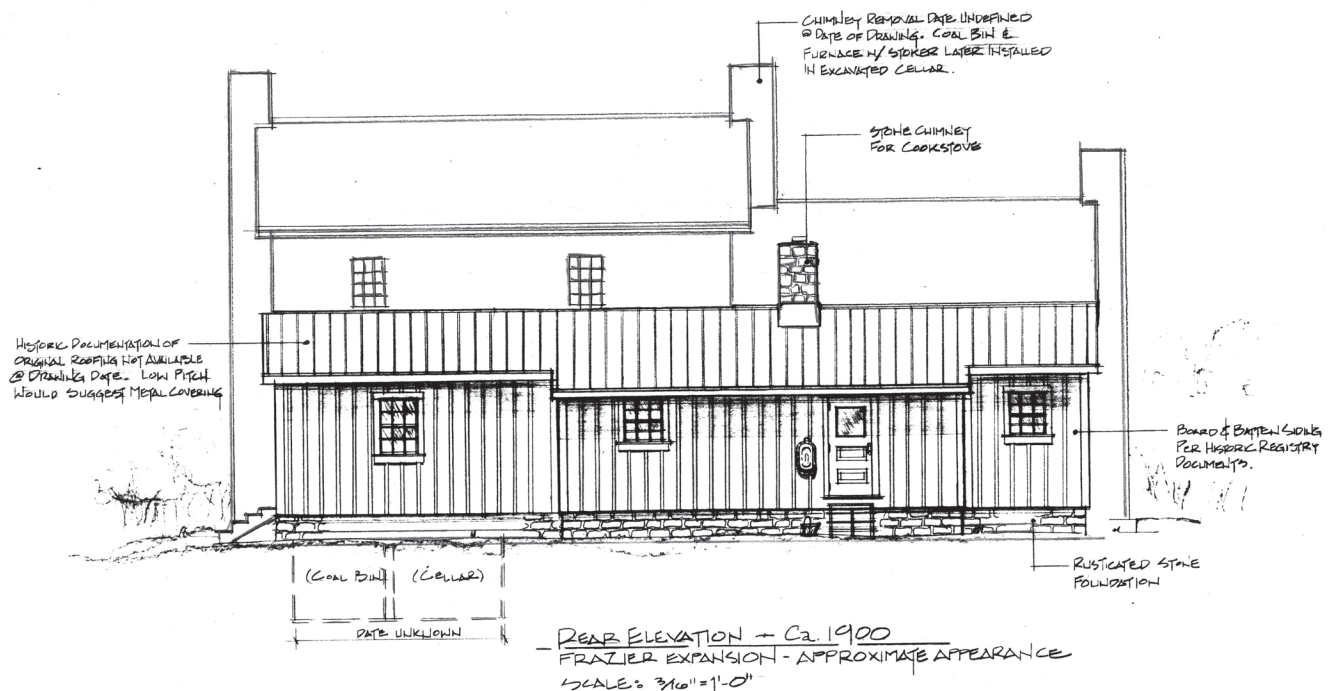
BELOW: REAR ELEVATION – CA 1900. FRAZIER EXPANSION – APPROXIMATE APPEARANCE. HISTORIC DOCUMENTATION OF ORIGINAL ROOFING NOT AVAILABLE AT DRAWING DATE. LOW PITCH WOULD SUGGEST METAL COVERING. UNDERNEATH THE EAST END OF THE ADDITION WAS A COAL BIN AND A CELLAR (DATE UNKNOWN). COAL BIN & FURNACE WITH STOKER LATER INSTALLED IN EXCAVATED CELLAR. RUSTICATED STONE FOUNDATION. BOARD & BATTEN SIDING PER HISTORIC REGISTRY DOCUMENTS. A STONE CHIMNEY FOR COOKSTOVE IN THIS ADDITION. CHIMNEY REMOVAL DATE (FROM ORIGINAL HALL & PARLOR PORTION) UNDEFINED AT DATE OF DRAWING. [NOTE: ACCORDING TO MARTHA HUDSON MCCLENDON WHO LIVED IN THE HOUSE DURING THE _____, THERE WAS A DOOR FROM THE KITCHEN AREA BY THE CHIMNEY (FOR COOKSTOVE) THAT OPENED TO STAIRS WHICH WENT DOWN TO THE FURNACE ROOM.]

PROBABLY WEST ELEVATION. CA 1900. FIRST FRONT PORCH (DATE UNDETERMINED) REPLACED BY MR. PAYNE IN LATE 1920S. HISTORICAL DOCUMENTATION OF APPEARANCE NOT AVAILABLE AT DATE OF SKETCH.

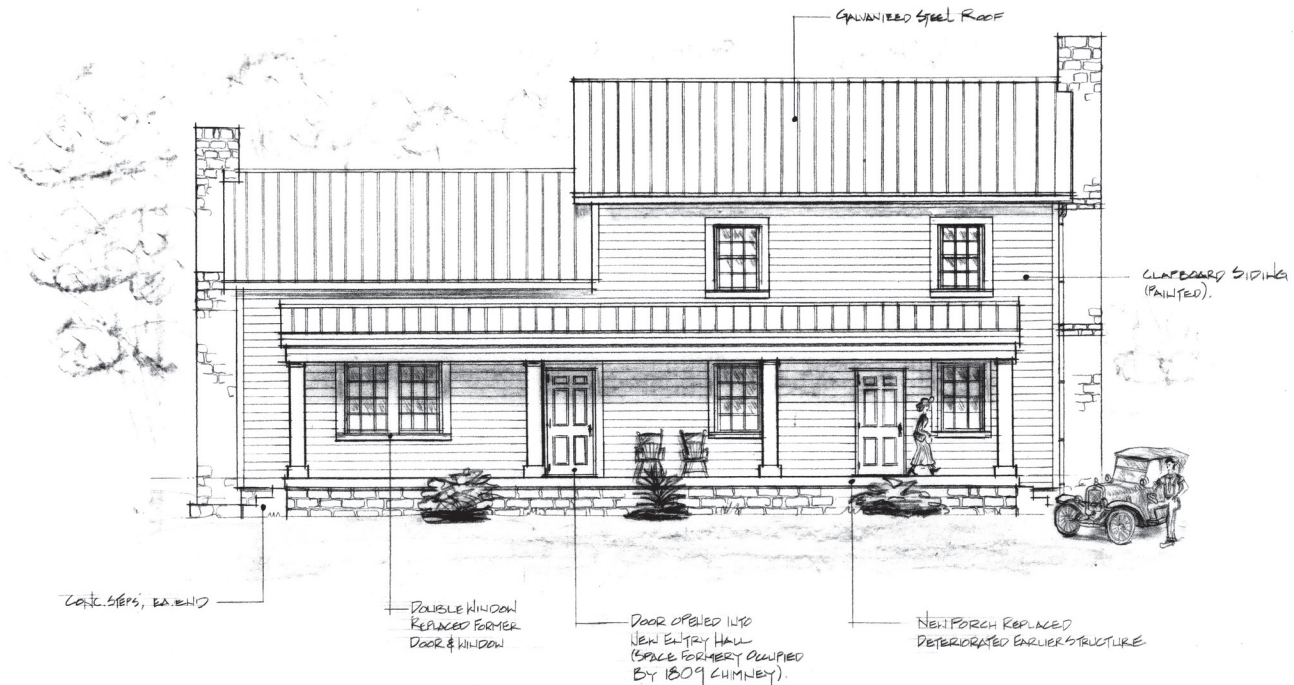
ca. 1930 FRONT ELEVATION
 WITH ALTERATIONS BY MR. LAVIN L. FAYNE
 SCALE: 3/16" = 1'-0"

BELOW: FRONT ELEVATION. 1930. CONCRETE STEPS, EACH END. POSSIBLE WINDOW (ON WEST-END OF PORCH) REPLACED FORMER DOOR & WINDOW. DOOR OPENED INTO NEW ENTRY HALL (SPACE FORMERLY OCCUPIED BY 1809 CHIMNEY). NEW PORCH REPLACED DETERIORATED EARLIER STRUCTURE. CLAPBOARD SIDING (PAINTED). GALVANIZED STEEL ROOF.
